Ground Isolation when the Video Feed has a DC Component

Application Note

AN/158

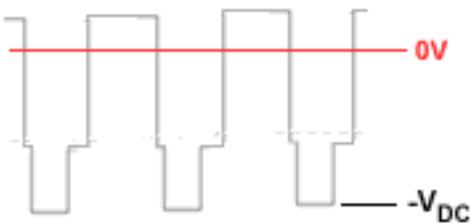
Fig. 3. White Signal across Transformer Winding

The transformer winding cannot support dc voltage, so that, as shown in Fig. 3, the video signal across it will be offset in the negative direction by an amount equal to V_{dc} .

Again refer to Fig 3. for the signal across the transformer primary. It has no dc component since it is offset by -0.8557V.
